## Gear-up Landing on Guam A Crew Chief's Version

**RB-47 53-4302**

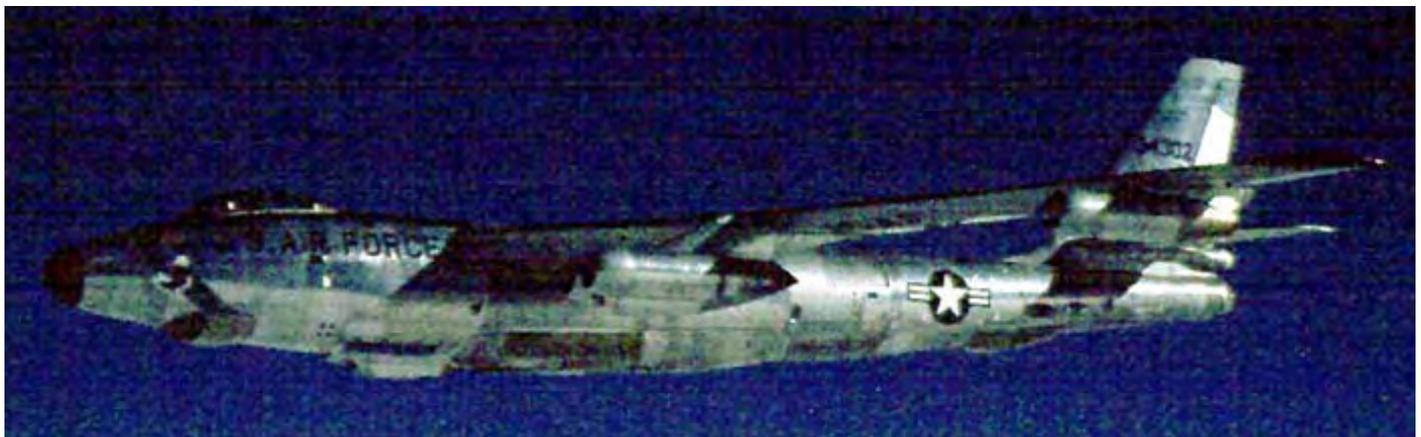
**Note: the forward gear doors partially open**

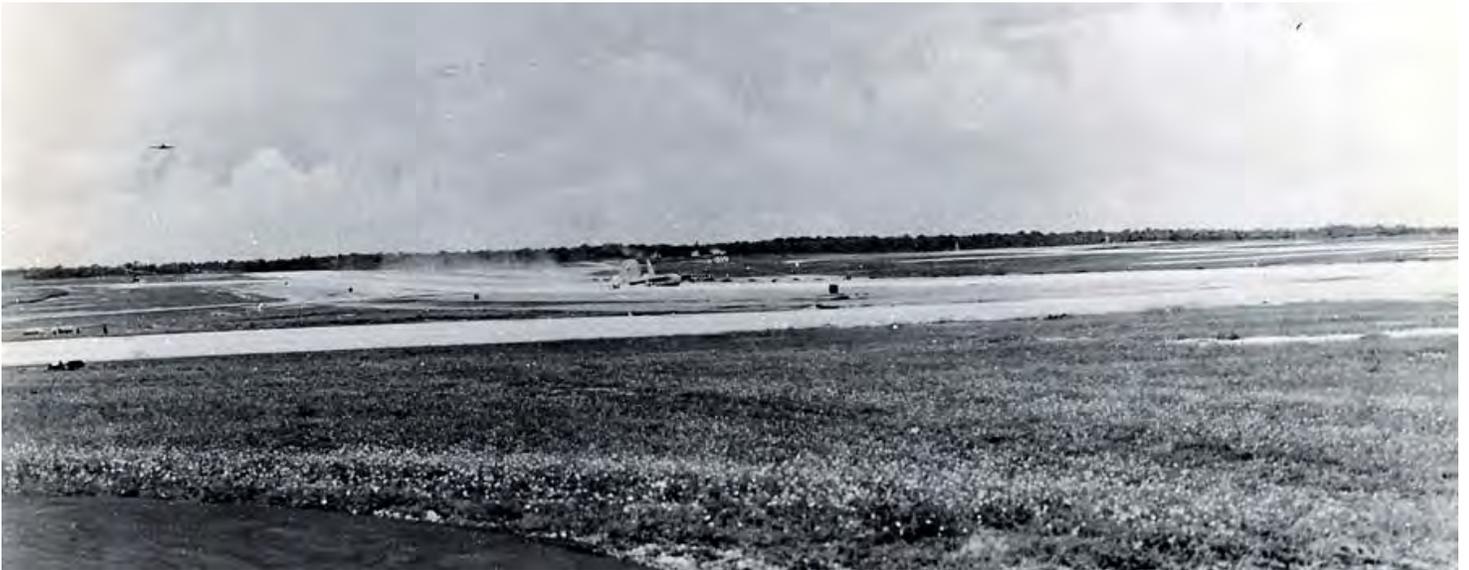
This picture shows the touchdown and the tanker behind and above.

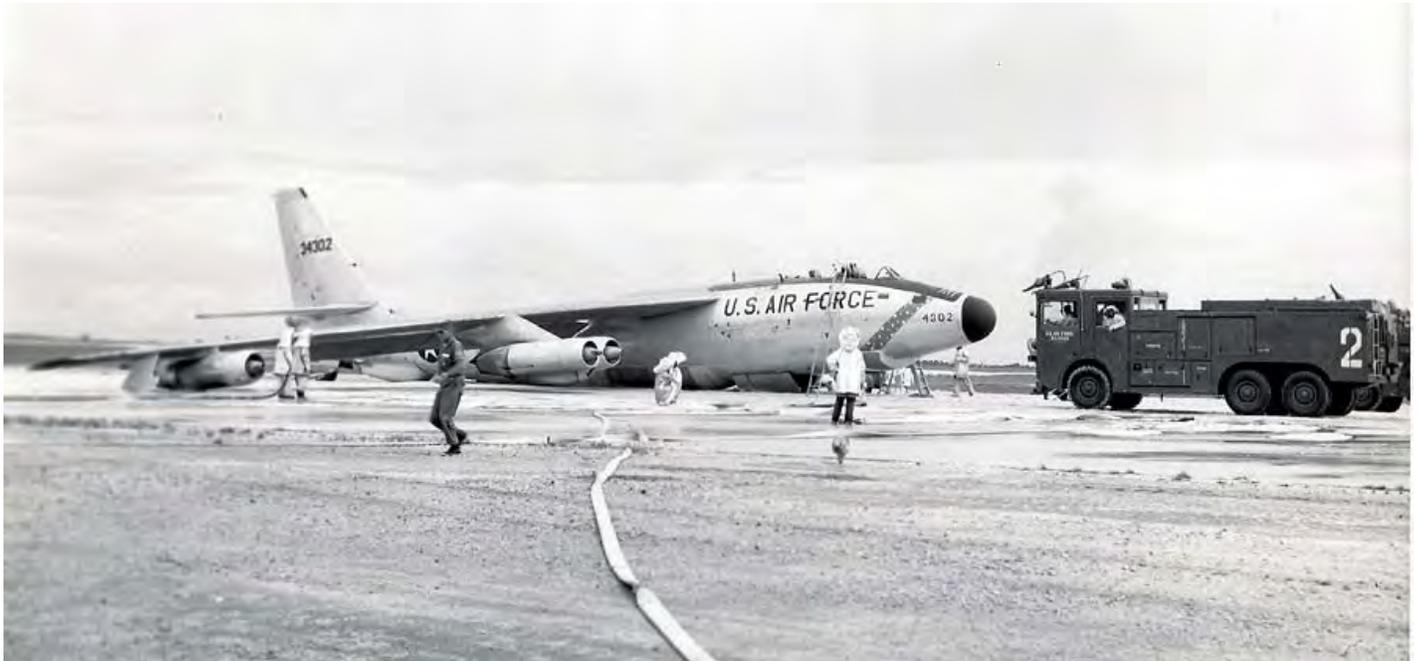
The 'ELGE' handle for the forward main gear would not move (it was later found that one of the ball bearings that rolls up and down the track in the retraction mechanism had split and was jammed in the track) Don recalled there was a 50ft strap in a pouch that was for emergency use to attach to an injured person's chute 'D' ring so they could be dropped out the entrance door and insure their chute would deploy. He used this strap to tie onto the handle so two people could pull on the handle. However the forward main gear lever would only move slightly or just enough to open the doors and drop the gear about 10 degrees down and would not move any more. Finally the use of the extra leverage and repeated pulling on the ELGE handle caused the release cable to brake. The ability to check the position of the forward main gear could be established by going down into the aforementioned crawlway about halfway and opening a small panel to view the gear position. Different procedures were tried along with suggestions from the Boeing Company. One procedure was to accelerate to 290 knots then do a pop-up to place 'G' forces on the plane. During this procedure Don laid in the crawlway while below 10,000 feet as the flight crew would accelerate and do a pop-up to pull 'G's to see if the gear would move. He had a good view of the landing gear out the little door in the crawlway until they pulled the pop-up, then the door would slam closed and he would be pinned down in the crawlway. After five in-flight refueling offloads in the local area at Yokota, and realizing a wheels up landing was now inevitable, Col. Riley decided to divert to Anderson AFB on the Island of Guam because of better facilities for a gear up landing.

**In this view you can see the forward gear doors are slightly open**

The aircraft was removed from the runway and with a minimal amount of work needed for it to be in flying condition. The retraction mechanism was replaced and the number six engine on 53-4302 were changed. A scab patch was put down the belly and five days later the airplane was flown back to Forbes AFB Kansas. It was thirteen months before it flew again.

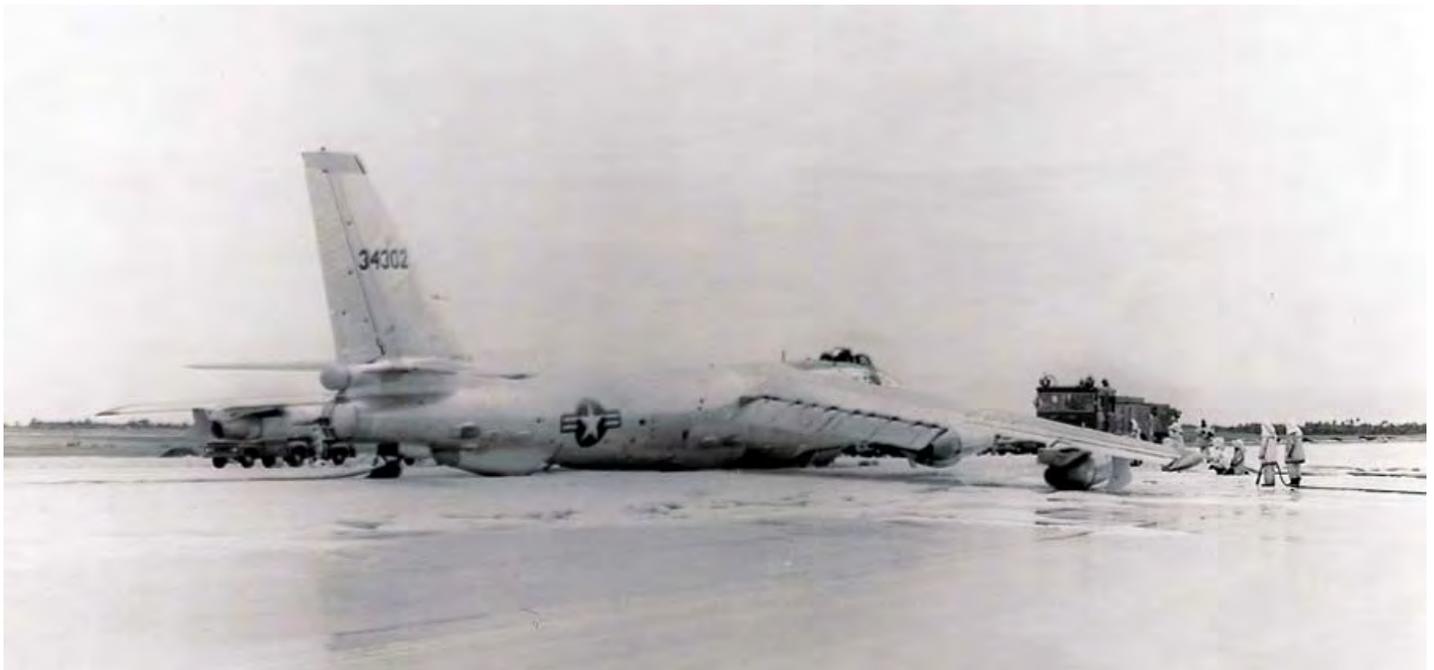
**This view shows that number six engine was slightly damaged. The left wing tip even though it was much higher was used as the exit point because of it being up-wind**
