## Gear-up Landing on Guam A Crew Chief's Version

**RB-47 53-4302**

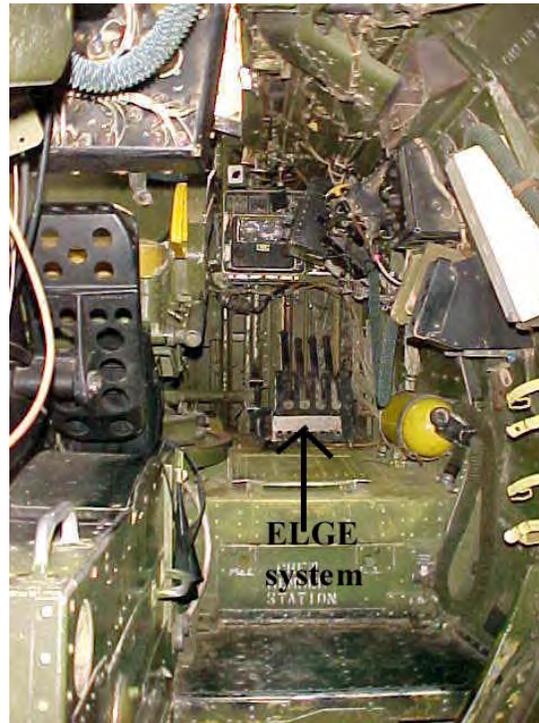
As this flight returned to Yokota to land the forward main gear would not extend. The normal procedure then was to use the ELGE stand (emergency landing gear extension) and through a cable and ratchet system, unlock and lower the gear and extend it to the down and locked position. This system was located to the left and slightly behind the co-pilot and consisted of four handles and lights that indicated safe or unsafe positions of all four of the landing gear.

Don attempted to lower the gear using the ELGE system but the forward main gear lever would not move. After several attempts were made to lower the gear the Command Post was notified and emergency procedures were started. A tanker was launched to refuel the plane while repeated attempts were made to lower the gear.

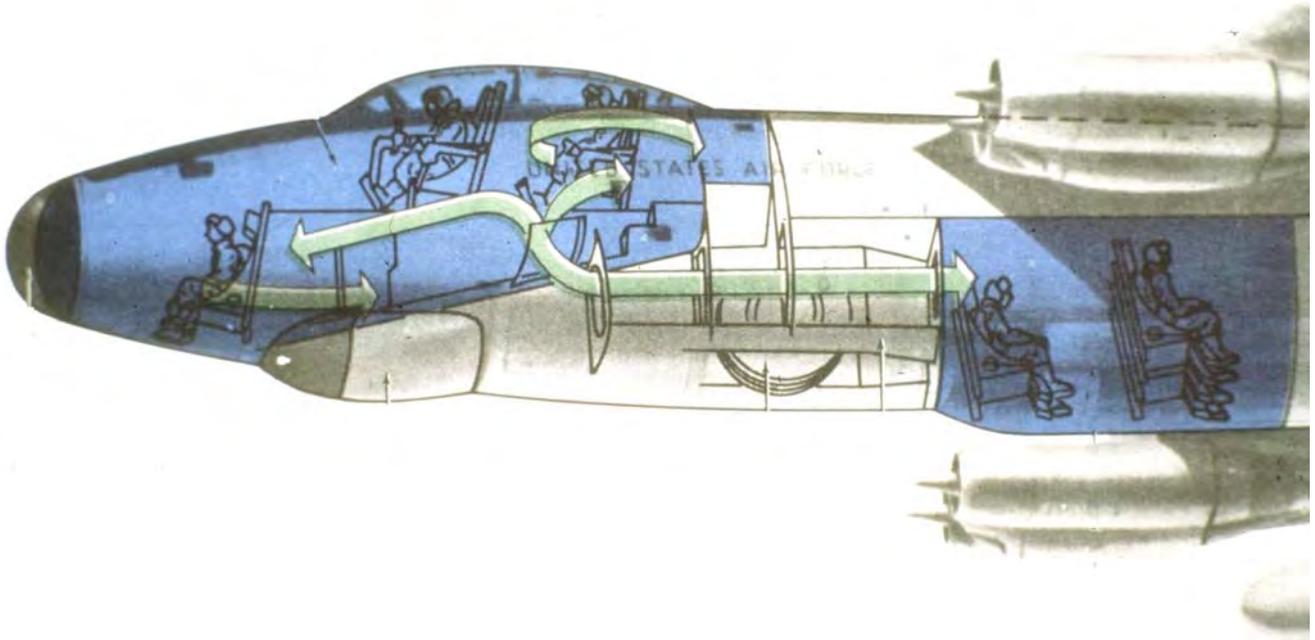
**Note: the forward gear doors partially open**

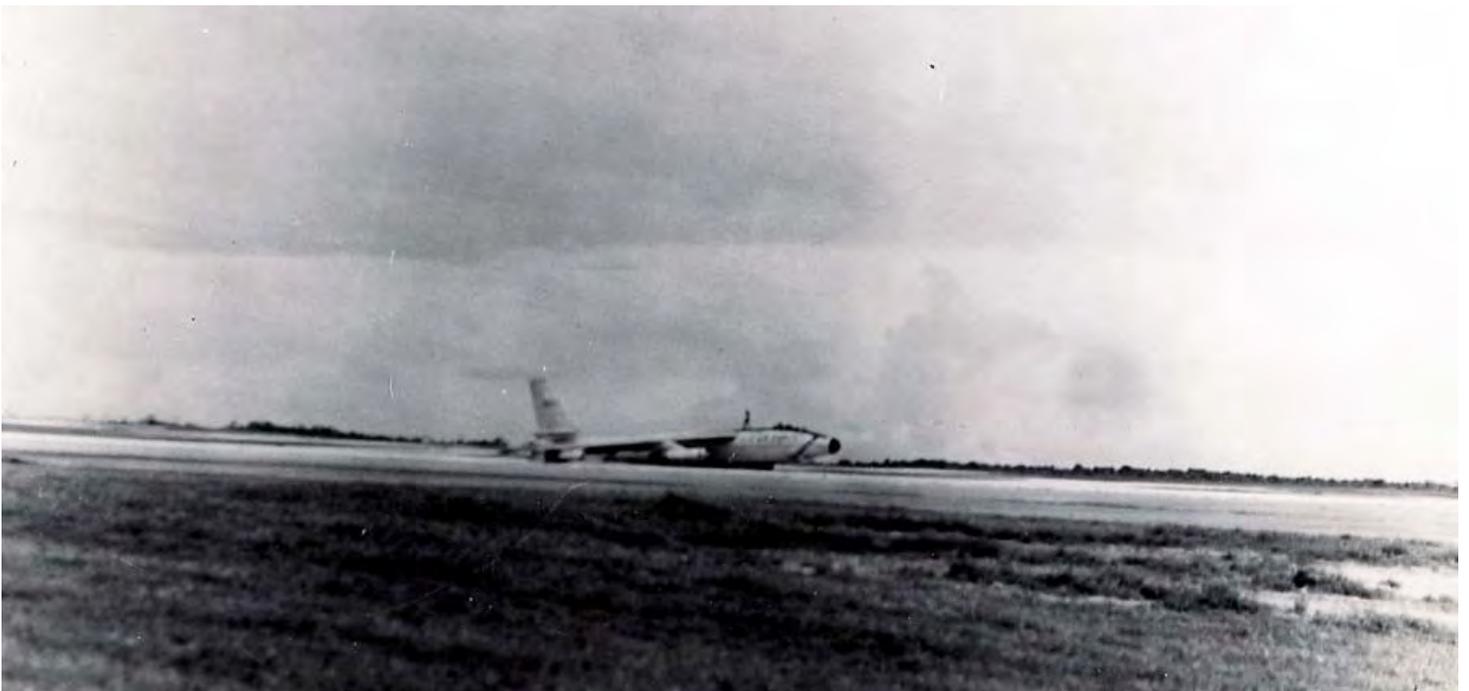
This picture shows someone climbing out of the cockpit and walking down the backbone of the aircraft.

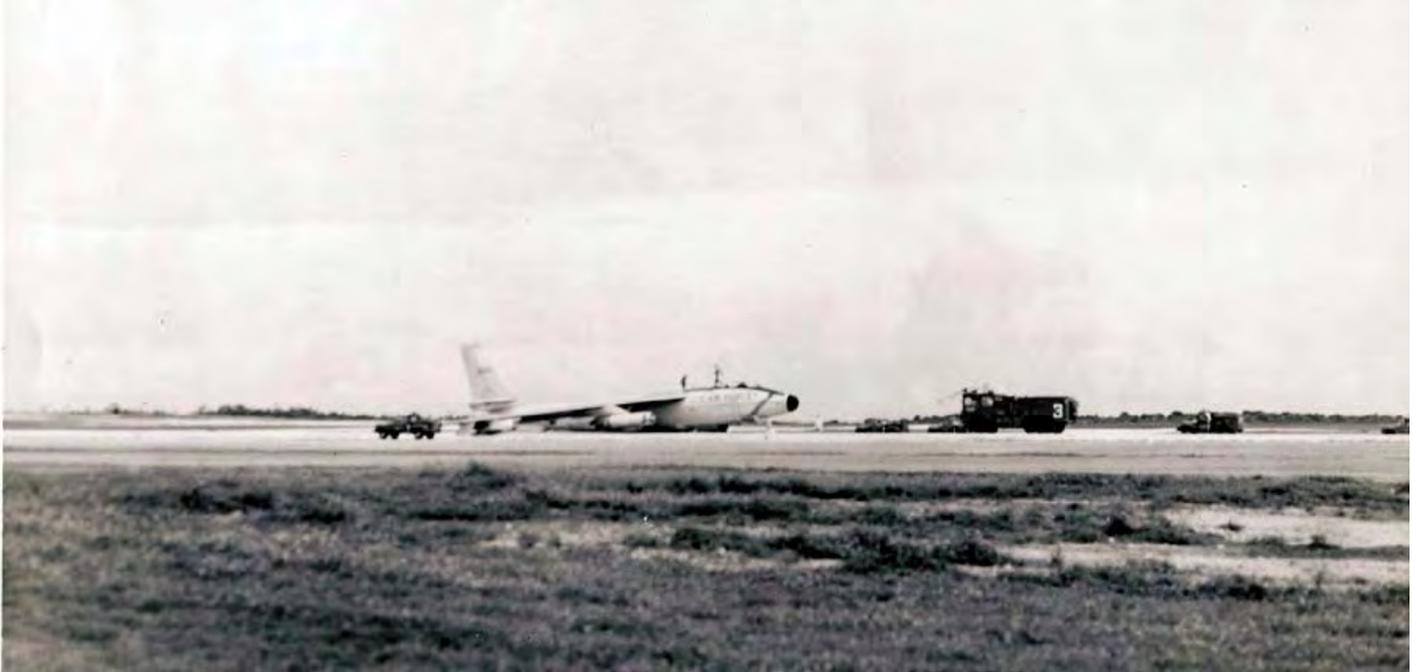
**This picture shows the fire department arriving and two more climbing out of the cockpit. They then walked down the left wing and made a small jump off the wingtip outboard of number one engine due to that wing being on the up-wind side in case fire broke out.**

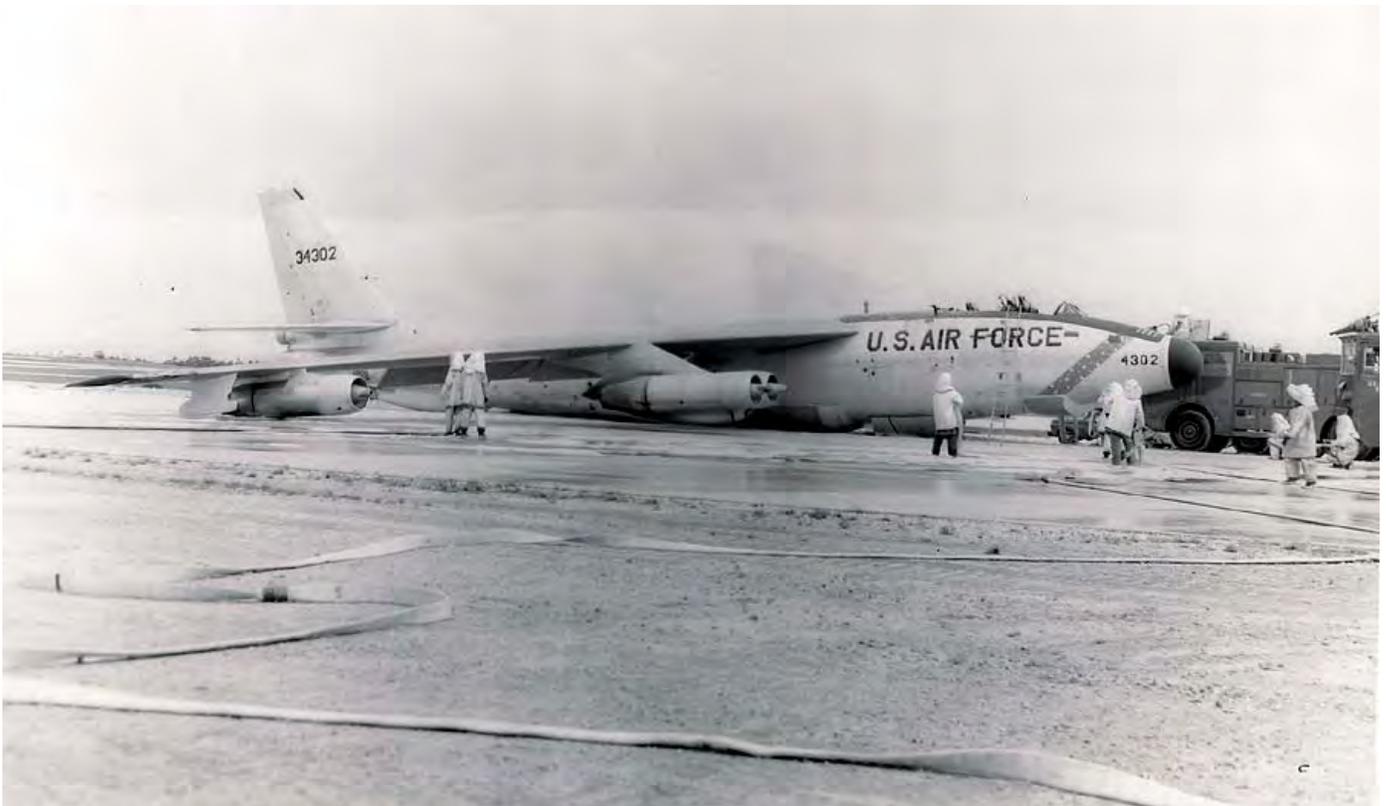
**This view show the fire department has everything under control.**

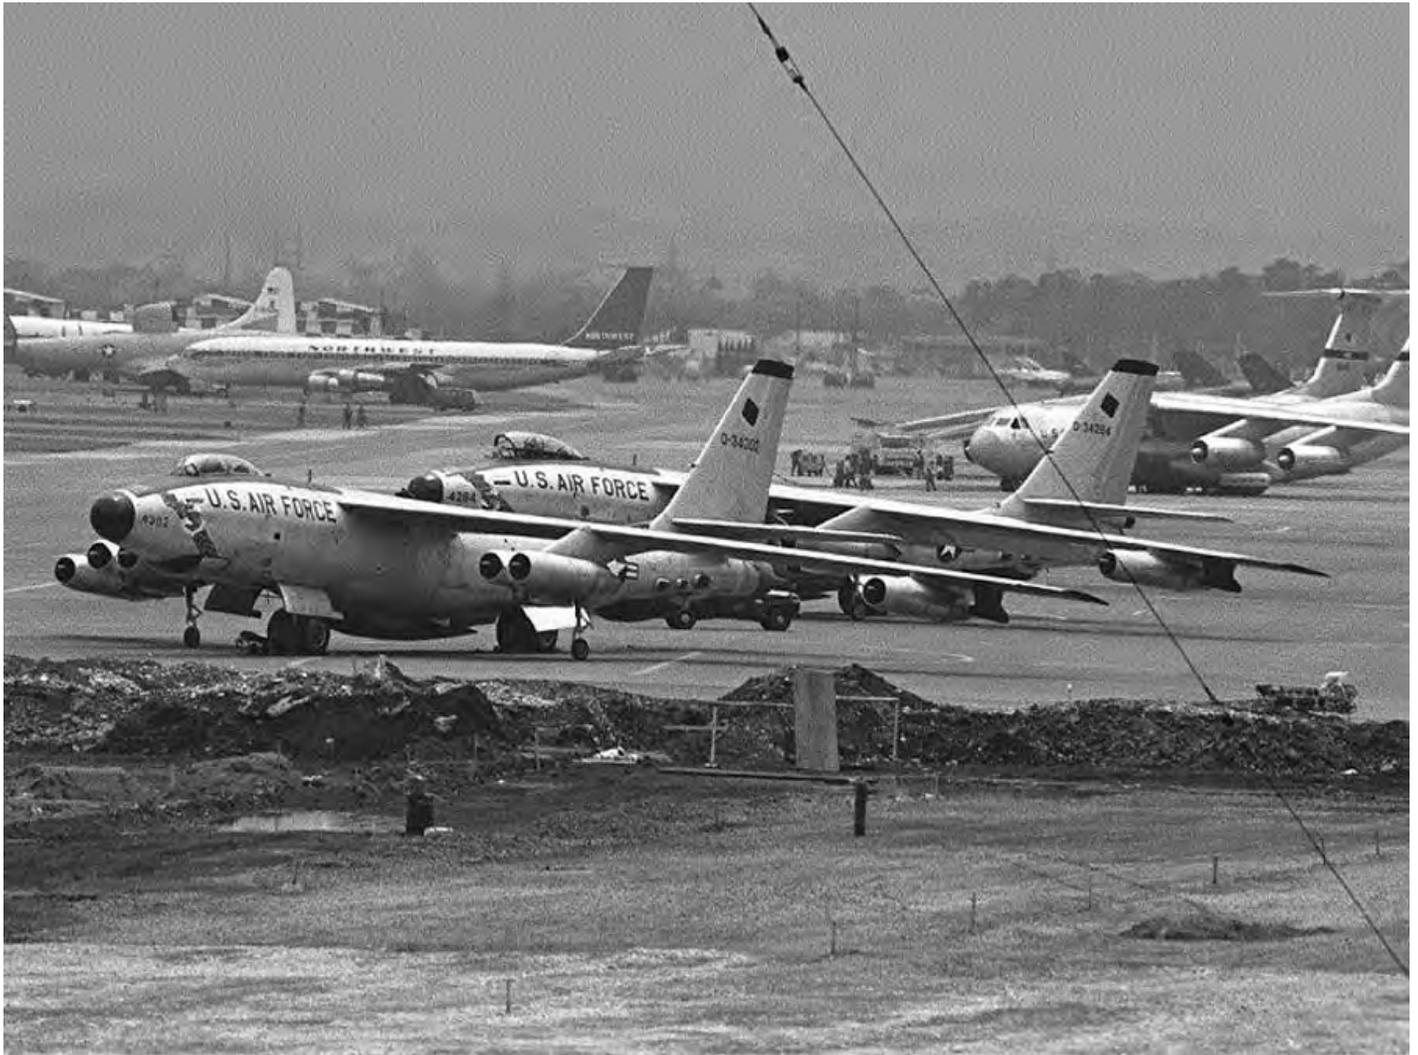
Here is a picture of the very same aircraft on duty again about four years later still on duty at Yokota once again. Don Foster was no longer the crew chief and stated he never worked on the aircraft again due to its extended maintenance down time from that landing.

The aircraft was removed from the runway and with a minimal amount of work needed for it to be in flying condition. The retraction mechanism was replaced and the number six engine on 53-4302 were changed. A scab patch was put down the belly and five days later the airplane was flown back to Forbes AFB Kansas. It was thirteen months before it flew again.
